## TECHNICAL SERVICE BULLETIN

**Technical Service Bulletin Number-TSB0010 – Step-N-Lock Maintenance**

**Date – 08/02/2019**

**Item, Unit or Assembly Affected – Step-N-Lock**

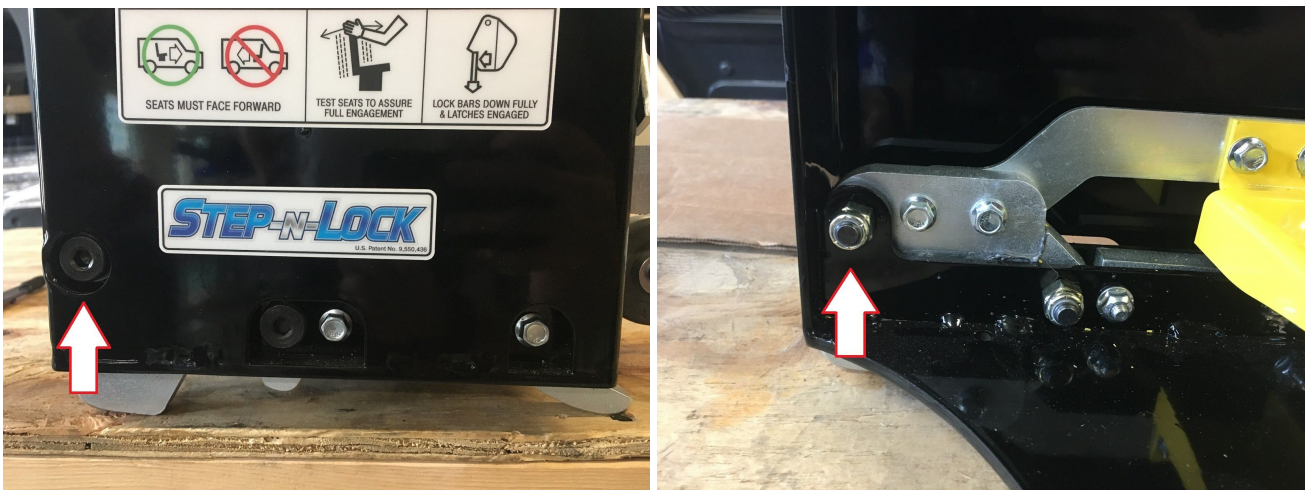
**Reason for Bulletin –** The pivot joint at the CAM bolt may become less binding over time and repeated use. As a result, the step-bar may fall to the “locked” position under its own weight, making the Step-N-Lock seat less convenient to relocate.

**Action Required –** Snug the indicated nut and bolt to prevent the step-bar from falling under its own weight. The step-bar should be easily moved, but not loose.
