TECHNICAL SERVICE BULLETIN

Technical Service Bulletin Number- TSB0001

Item, Unit or Assembly Affected- Step-N-Lock Seat Base Assemblies (Roller Wheels)

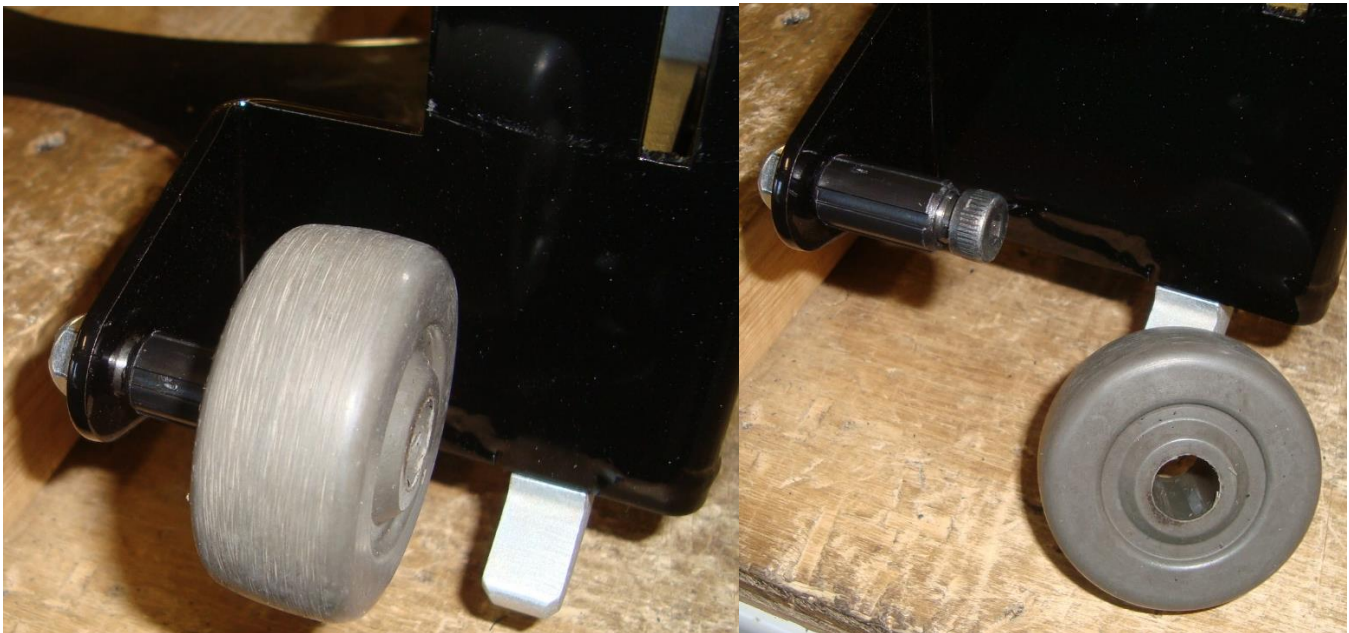
Reason for Bulletin- Due to an upgrade in the Roller Wheels in which the style and diameter of the roller wheel was changed from a 2-1/2" OD Black wheel to a 2" OD Gray wheel, it is possible that, under certain conditions, a tube in the center bore of the wheel may pull out of the wheel and allow the wheel to slip past the head of the shoulder bolt (axle) on which it rotates. This may allow the roller wheel to come completely off the seat base. This would then make it impossible to roll the base as intended.

Action Required- Using a 5/32" Hex Socket Bit (or Allen wrench) and a 7/16" wrench, remove the shoulder bolt (axle) and nut. Remove the dislodged sleeve from the Shoulder Bolt and press back into the roller wheel. Re-install in reverse order BUT add / install a Thin (.040" thk. or less) 5/16" Flat Washer under the head of the Shoulder Bolt. This will retain the wheel and prevent future dislodgement. Do not over-tighten or use too thick a washer as this may bind the wheel. Check the wheel for free rolling after tightening. The recommended washer is a Fenton Mobility Part Number FW317504SS or a *Fastenal* Part Number 71015 (or Equivalent .750"OD x .340"ID x .040" Thk. Stainless Steel). Washers may be ordered free of charge directly from AbiliTrax and Labor reimbursement claims may also be made by contacting mary@abilitrax.com. Labor allowance will be at a rate .25 hrs @ \$90.00 per hour (\$22.50 per seat).
