TECHNICAL SERVICE BULLETIN

Technical Service Bulletin Number- TSB0007

Item, Unit or Assembly Affected - Early Versions of CamLock 2 Seat Legs with Lock Levers. Current versions of the CamLock 2 Seat Legs have been factory modified to incorporate this change and are not affected

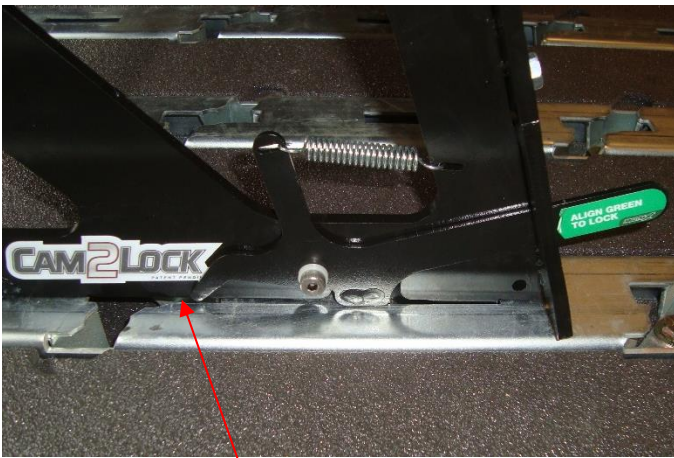
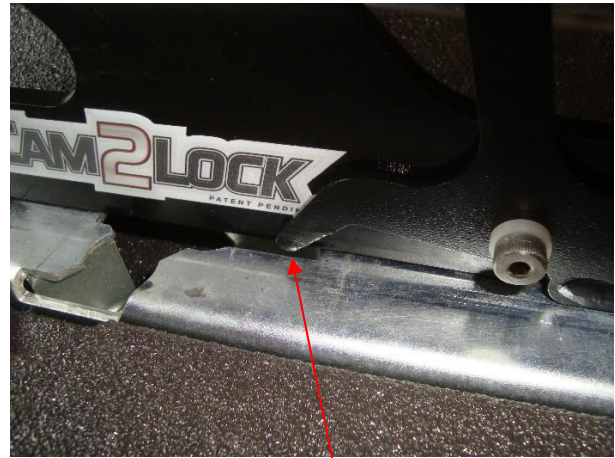
Reason for Bulletin - Difficulty in unlatching / removing CamLock 2 Seat Legs. Early versions of the CamLock 2 were equipped with a Latch (Locking) Lever that incorporated a “bird’s beak” design at the end of the Lever. It was the intent that this portion of the lever drop into the opening in the AbiliTrax Rail to assist in disengaging the seat. Due to certain tolerance accumulations, etc., it is possible that this portion of the lever may in fact actually make raising this lever to the dis-engagement position extremely difficult.

Action Required – Since it has been determined that this feature offers no real mechanical advantage in the removal of the seat, this portion of the Lever can be safely removed without compromising the safety, functionality or integrity of the Seat Base.
