TECHNICAL SERVICE BULLETIN

Technical Service Bulletin Number-TSB0005 – Shift-N-Step Ski Alignment

Item, Unit or Assembly Affected – Shift-N-Step

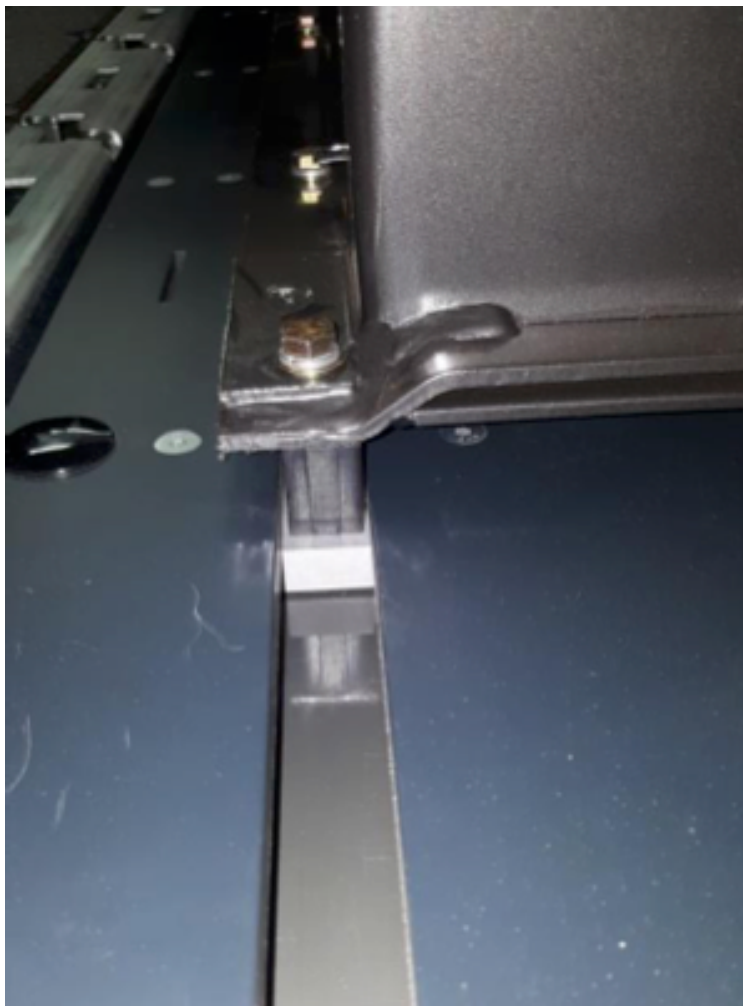
Reason for Bulletin – Due to the curvature of the base of wheelchair lifts (especially Braun-brand), improper installation will result in misaligned skis in the Shift-N-Step tracks.

Action Required – Follow proper installation procedure according to training and provided manuals. Before the lift is installed, ensure Shift-N-Step skis are moving freely without noticeable obstruction. If they are not moving smoothly, first make adjustments to the middle column of Allen bolts (4th column from the left, 4th column from the right) on the base plate.

Once the skis are moving freely, secure the lift to the Shift-N-Step while inserting plastic shims to compensate for the curvature of the lift base. The shims should be applied such that they prevent the bolts from bending the skis to the curved shape of the lift base.

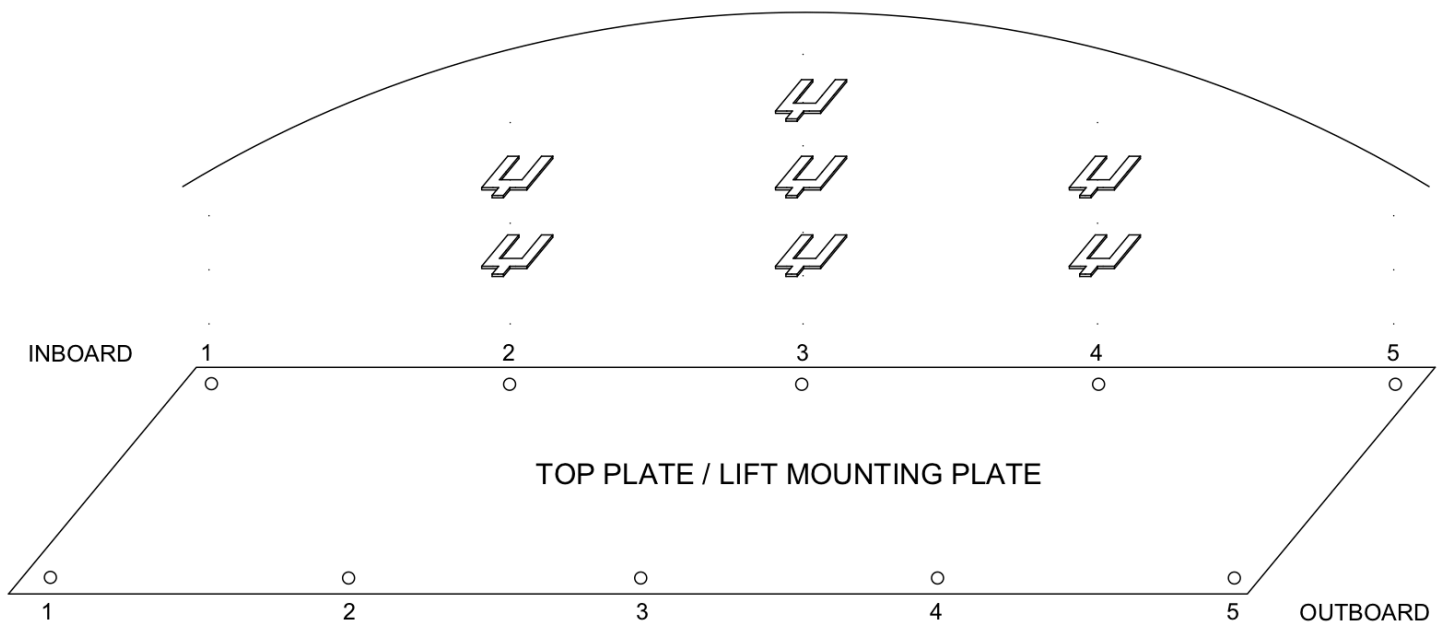
Figure 1 Shim Placement

Figure 1 below shows the recommended shim pattern:

- Two (2) shims in Column 2, inboard and outboard
- Three (3) shims in Column 3, inboard and outboard
- Two (2) shims in Column 4, inboard and outboard
- A total of 14 shims
