TECHNICAL SERVICE BULLETIN

Technical Service Bulletin Number-TSB0006 – Air Condition/Heat valve recall

Item, Unit or Assembly Affected – Air Condition/Heat valves

Vehicles(s) Affected – 2018 RAM ProMaster Units with ProAir Heat/AC Units sold under the GSA Contract / Masters Transportation

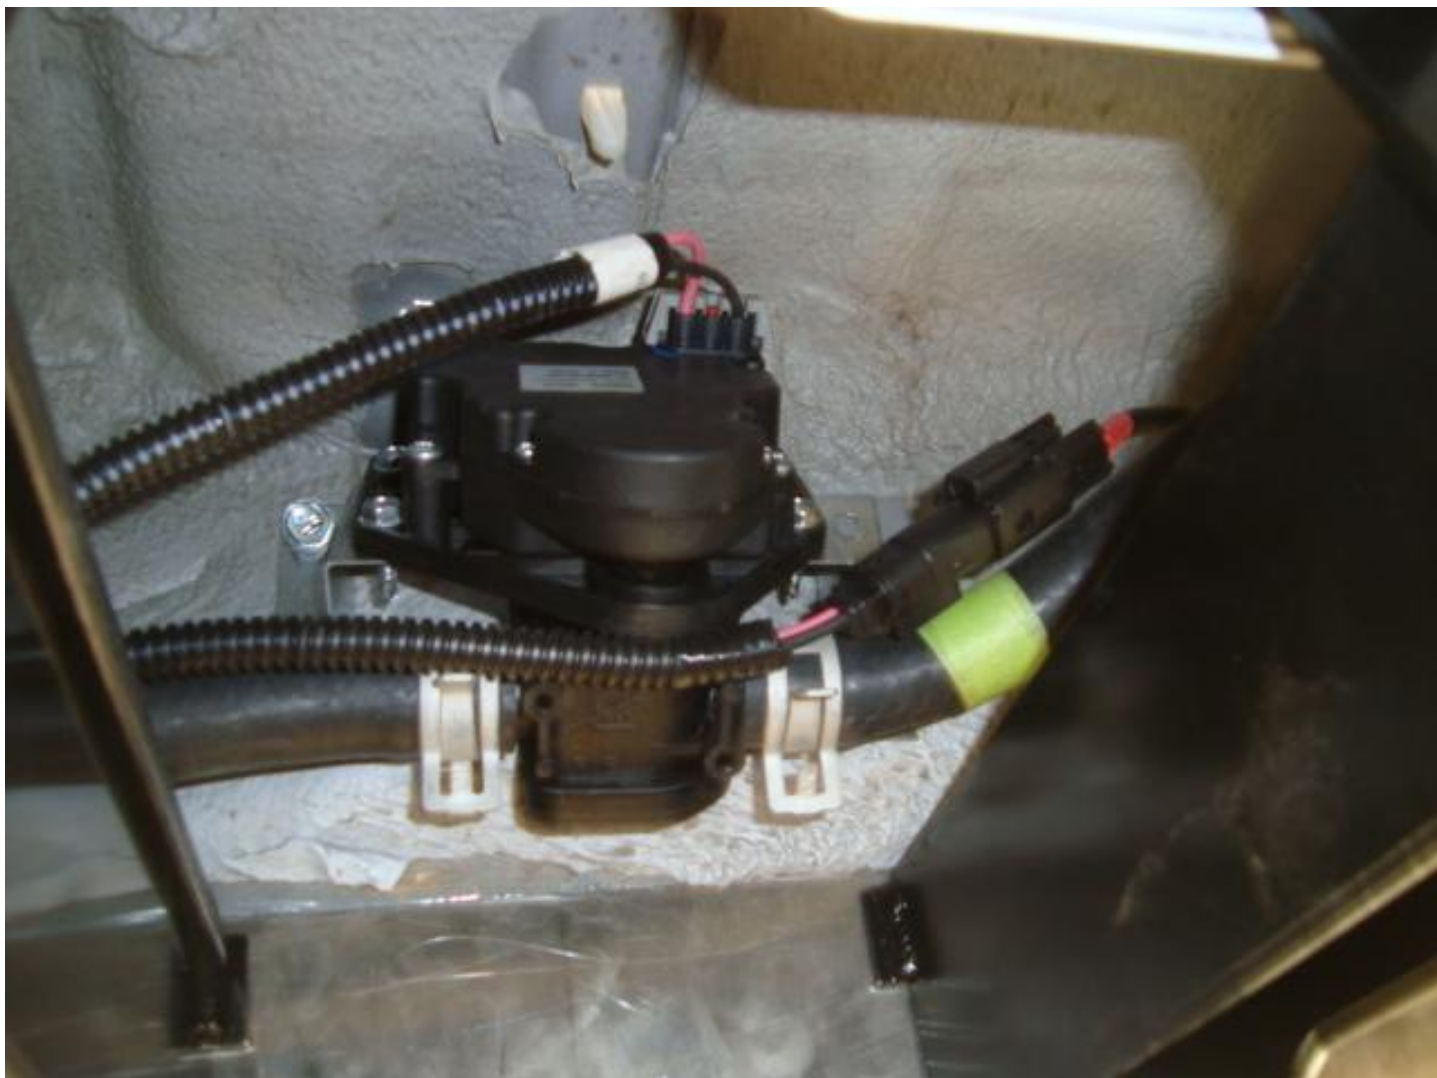
The old valve unit is shown installed in the image above. To begin, disconnect the wire harnesses.

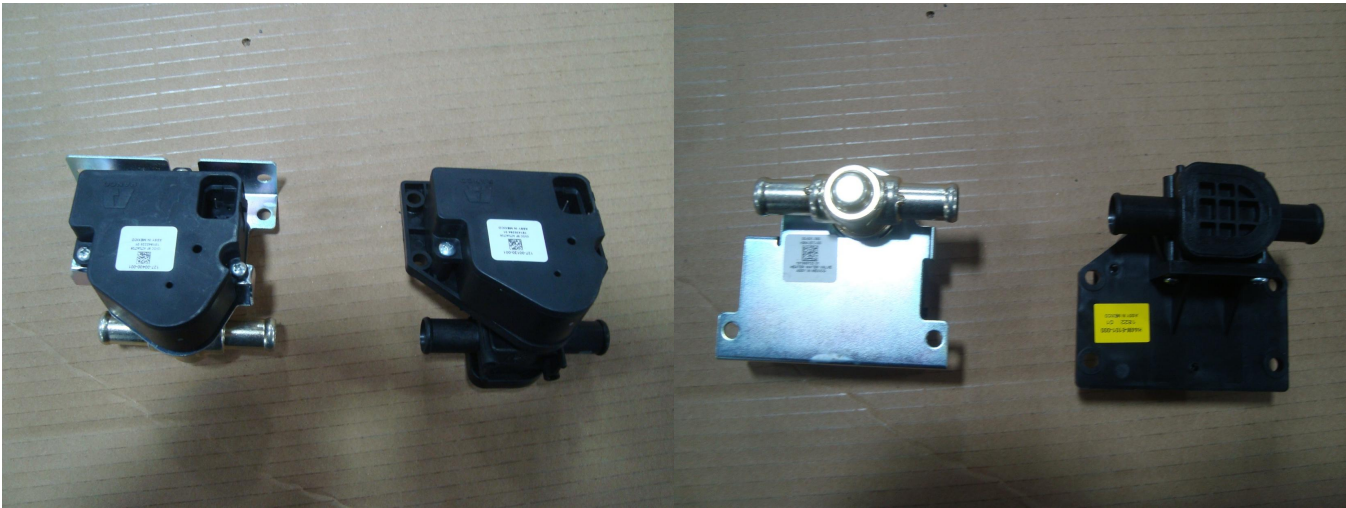
The new unit is shown above on the left. The old unit to be replaced is shown on the right.
